Sapstain, also called bluestain, is a fungal stain in timber caused by the presence of pigmented fungal hyphae in the wood. Sapstain is commonly associated with softwood timbers, particularly pine, but also occurs in hardwoods. Some timbers, like ash eucalypts, are light in colour. When the dark strands of fungal hyphae grow in the wood they appear as dark coloured 'stains' on the light-coloured timber.

Sapstain and its prevention

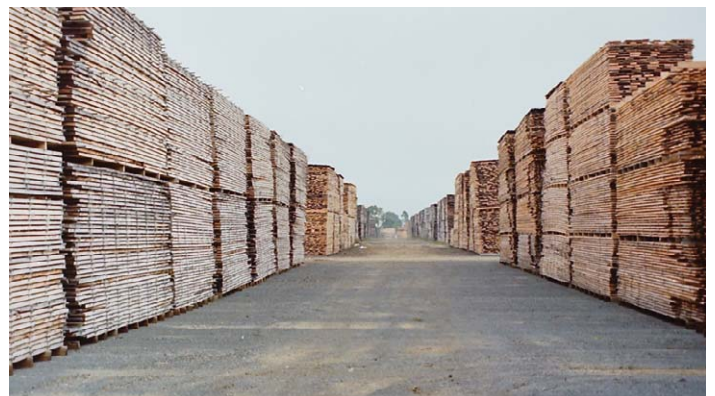
An example of good environmental controls against sapstain with no mud, timber above a layer of gravel, timber racked out and not block stacked and adequate ventilation between timber stacks.

Sawn timber: Various factors within the sawmill environment may exacerbate the sapstain problem. Sawmill residues, tall grass and weeds, and mud provide sources of infection for sapstain fungi. Timber stacked in confined situations, particularly under-cover and without adequate ventilation, promotes fungal stain development. Reduce infection potential in and around the drying yard and shed by removing grass and weeds and preventing the buildup of mud. Adjust spacing to allow for adequate ventilation between stacks of timber. Use clean, dry racking sticks when stacking timber. Do not block-stack timber.

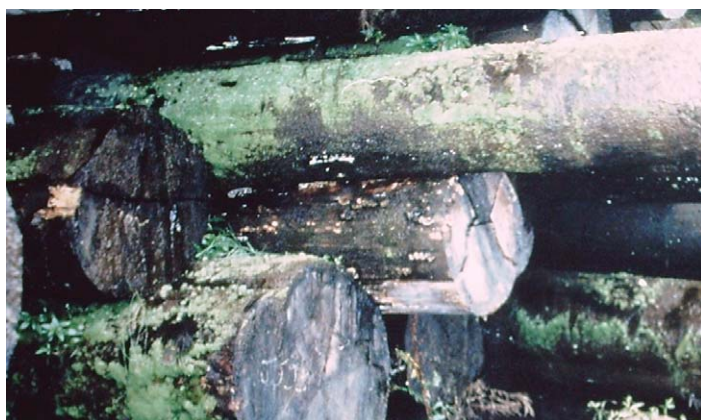
Mill hygiene is critical to preventing the spread of sapstain fungi.

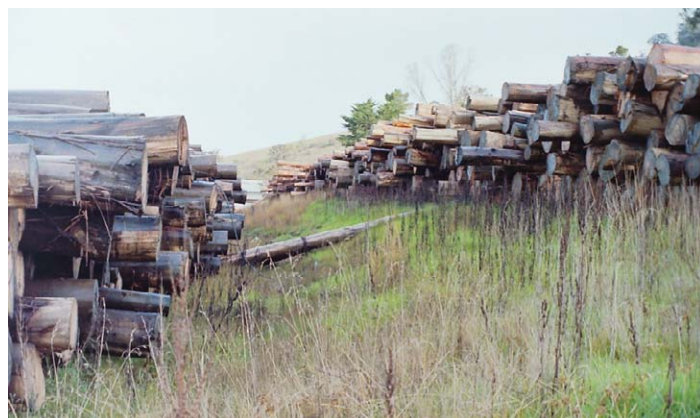
Removing tall grass and weeds from areas where timber is stored may help to reduce the spread of sapstain.
